# PUBLIC ROADS

JULY-AUGUST-SEPTEMBER 1946

# A STUDY OF BITUMINOUS-COATED CORRUGATED SHEET METAL CULVERTS

BY THE DIVISION OF PHYSICAL RESEARCH, PUBLIC ROADS ADMINISTRATION

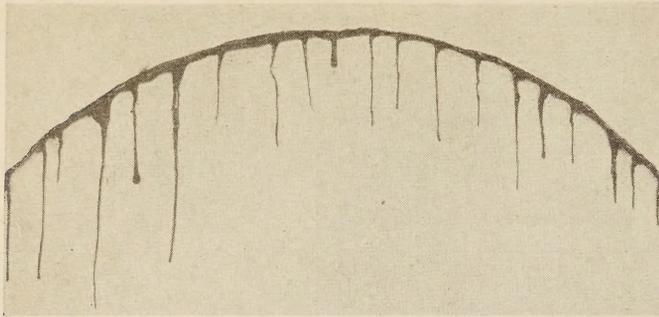
FIGURE 1.—TYPICAL CONDITION OF FLOW FROM CRESTS OF CORRUGATIONS IN THE TOP QUARTER INSIDE THE CULVERT PIPE.

**Flow.**—In some culverts a displacement of the asphalt coating by flow was noted. This condition occurred at the top of the pipe and was in the form of strings of asphalt hanging from the crests of the corrugations. Flow is illustrated in figure 1, which shows the coating cut from the corrugations, reassembled, and photographed.

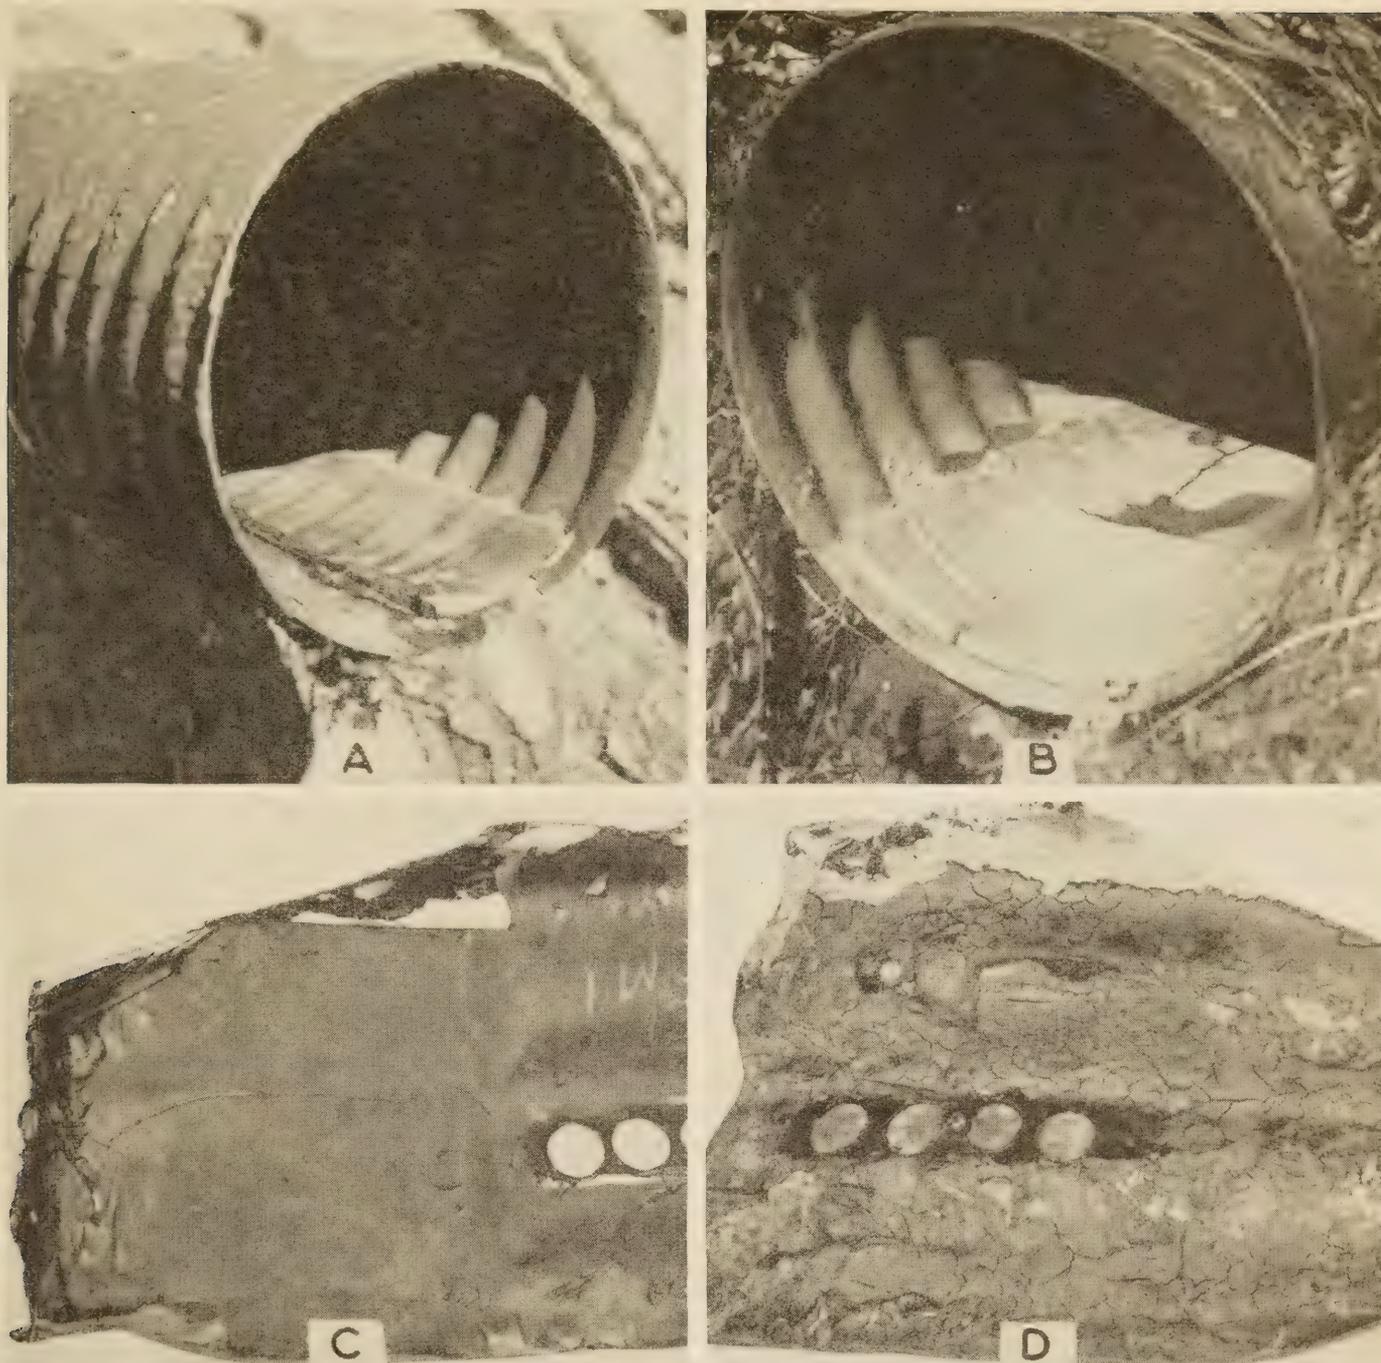
FIGURE 2.—BITUMINOUS-COATED GALVANIZED METAL PIPE: (A) SEVERE LONGITUDINAL CRACKING; (B) CRACKING OF ASPHALT PAVEMENT; (C) INSIDE VIEW OF SAMPLE CUT FROM OUTLET END OF PIPE. CONDITION APPEARS TO BE GOOD BUT ADHESION TEST (ROUND SPOTS) SHOWS LOW ADHESION; AND (D) OUTSIDE OF SAMPLE SHOWN IN (C). THIS PORTION OF THE PIPE WAS IN CONTACT WITH SOIL. TESTS SHOWED POOR ADHESION.

were inspected. The pavements in 7 culverts were rated good, 4 were checked, 13 were cracked only, and 2 showed sufficient loss of coating to expose the metal. Typical conditions are shown in figure 2.

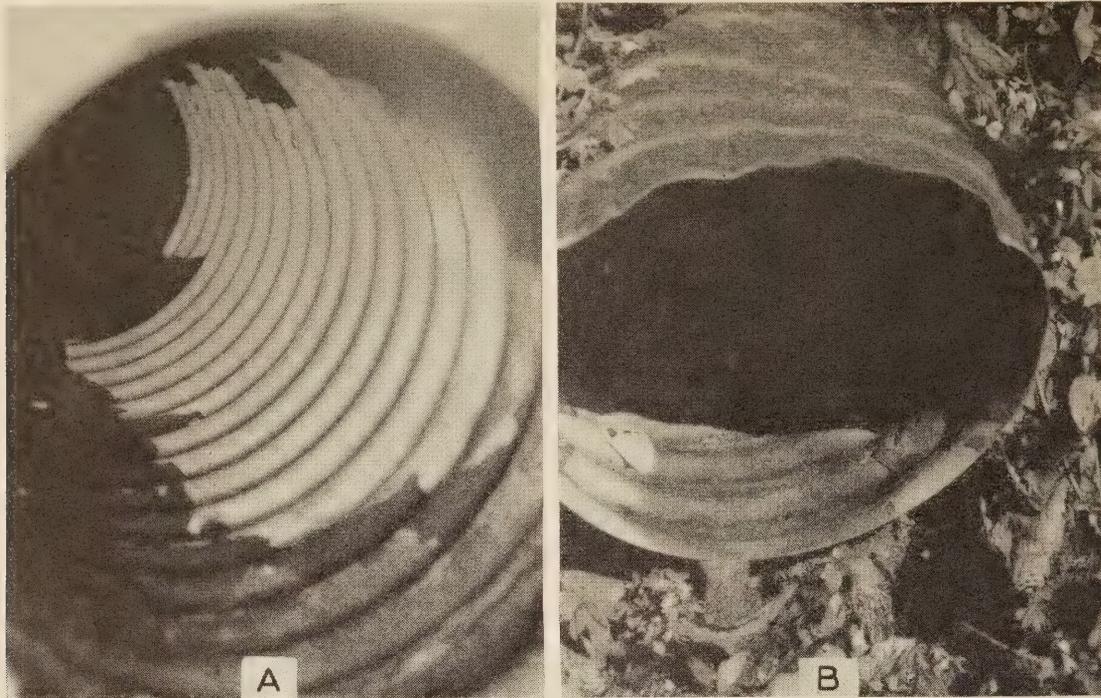
FIGURE 3.—A, ASPHALT COATING STRIPPED FROM WALL BY WATER SURGING THROUGH THE CULVERT ON 47 PERCENT GRADE; B, LOSS OF PAVEMENT FROM SAME CULVERT WITH RUSTING OF EXPOSED METAL.

The inside coatings above the inverts also showed more deterioration than on section 2M-1. For 6 of the 11 culverts inspected the coatings were good, 1 was checked only, and 4 showed some loss of coating. One culvert, which had an extremely high loss of coating on the inside walls, is of special interest. This culvert was installed on a 25° skew on a grade of 47 percent with a head wall at the inlet end. It appeared that during heavy rainfall water ran down the gutter and into the pipe at high velocity. It struck the side of the pipe above the pavement at an angle and had stripped a large area of the asphalt coating from the side wall. This condition was repeated on alternate right and left sides of the pipe for a considerable distance down the pipe. Figure 3, A shows the high loss of coating from the inside wall near the inlet. The loss of asphalt coating from the pavement is illustrated in figure 3, B.

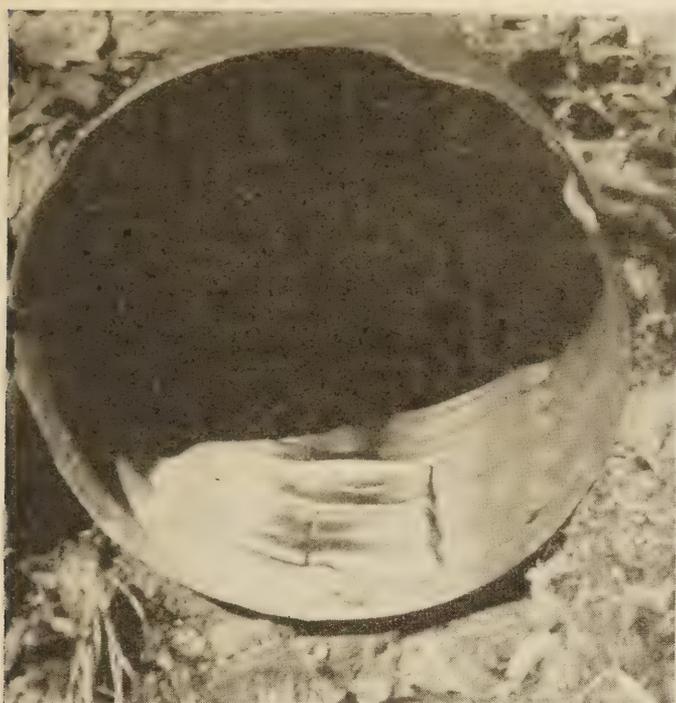
Typical conditions of the culvert pipe installed on sections 2M-2 and 2N-1 are shown in figures 4 and 5.

FIGURE 4.—BITUMINOUS-COATED ASBESTOS-BONDED PIPE SHOWING SEVERE CRACKING OF PAVEMENT AT OUTLET END.

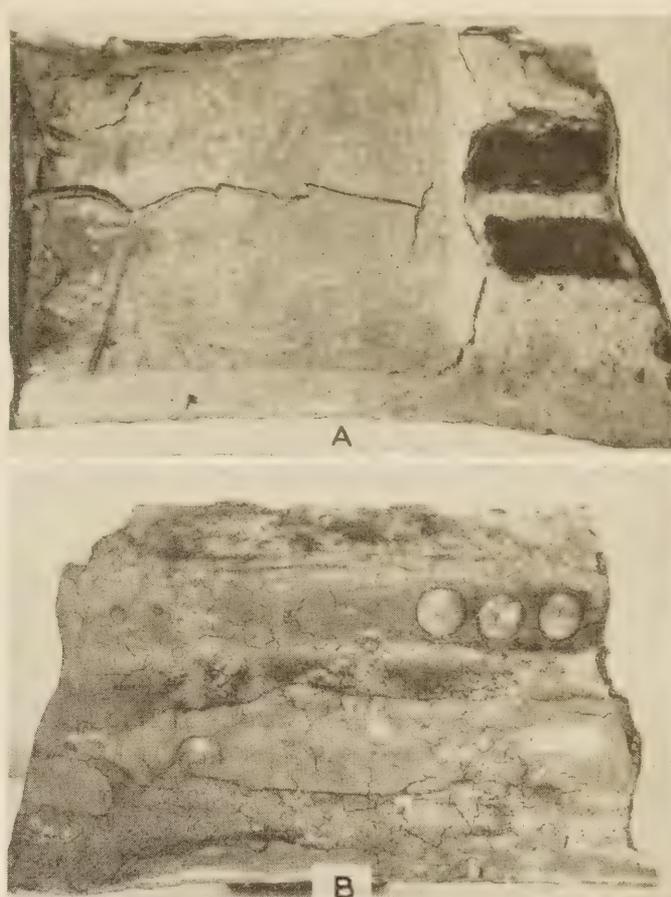
FIGURE 5.—SAMPLE TAKEN FROM OUTLET END OF BITUMINOUS-COATED ASBESTOS-BONDED METAL PIPE. (A) INSIDE SHOWS CRACKED PAVEMENT; (B) OUTSIDE SHOWS GENERAL CONDITION OF COATING WHICH HAS BEEN IN CONTACT WITH SOIL SURROUNDING CULVERT.

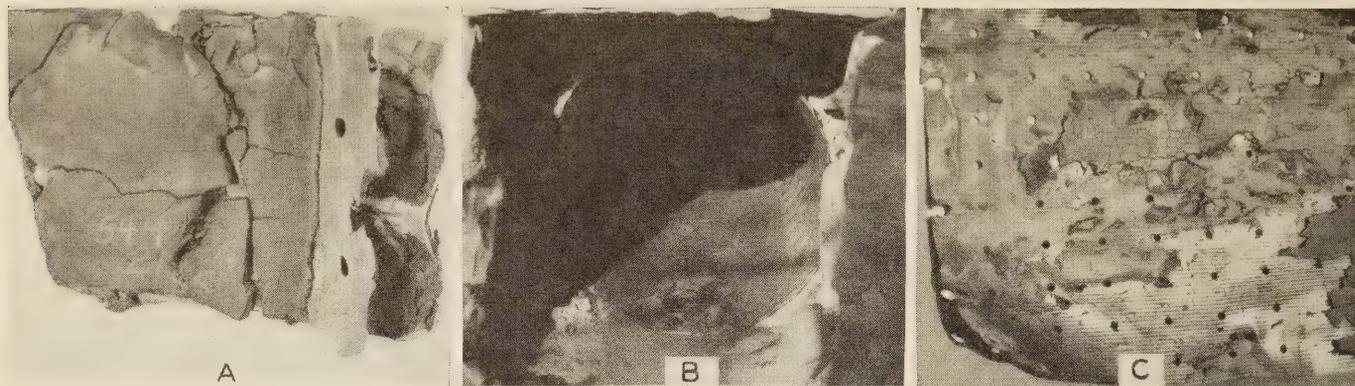
The conditions of some of the culvert pipe installed on sections 2N-2, 2P-1, and 2V-1 are illustrated by figure 6.

FIGURE 6.—METAL-REINFORCED ASPHALT PAVING. (A) SAMPLE FROM OUTLET END SHOWING LOOSENING OF REINFORCEMENT; (B) COATING ON REINFORCING PLATE BADLY BROKEN WITH SOME LOSS; AND (C) SECTION OF REINFORCING PLATE SHOWING LOSS OF COATING AND RUSTING OF EXPOSED METAL.

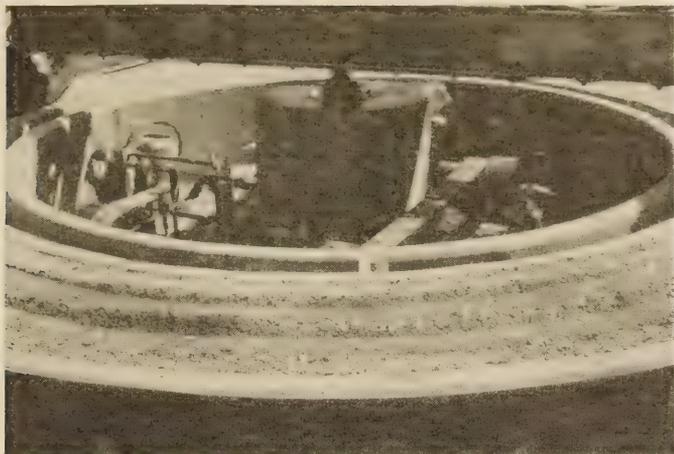
FIGURE 2.—APPEARANCE OF SECTION 5 AFTER 110,000 WHEEL-TRIPS.

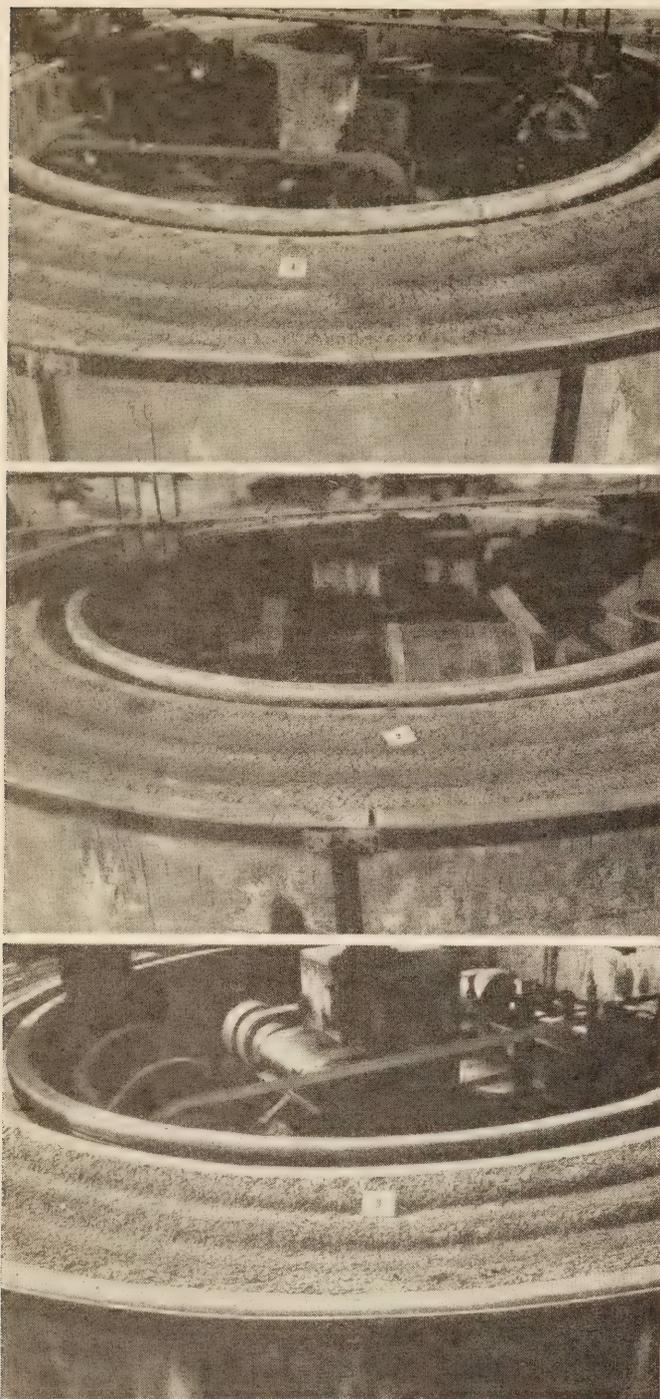
FIGURE 3.—CONDITION OF SECTIONS 1, 2, AND 3 AT THE END OF THE TESTS.

The average vertical displacement of section 3 was approximately 0.24 inch at 260,000 wheel-trips, the conclusion of testing with water at the 2½-inch elevation. This was more than for any other section except section 5 which had failed at about 100,000 wheel-trips. Displacements continued uniformly under concentrated traffic with the water level raised to 4½ inches above the top of the subbase. By the time traffic had reached 300,000 wheel-trips, the average vertical displacement was well over 0.25 inch, mud and water began appearing through cracks in the surface, and the section was rated failed although traffic was continued over the section to the end of the test without difficulty.

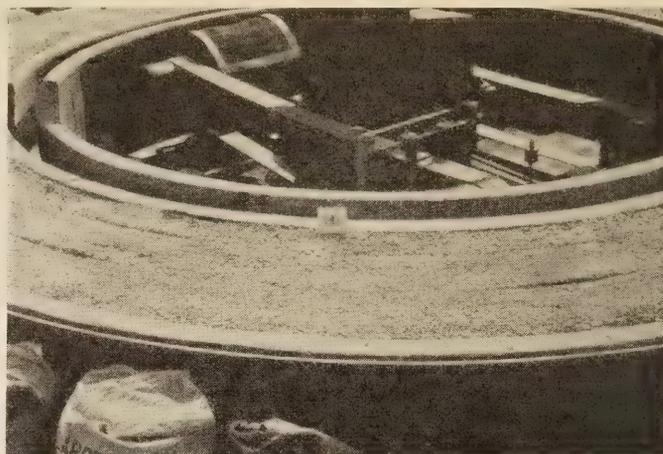
FIGURE 4.—SECTION 4 AFTER 110,000 WHEEL-TRIPS. NOTE SIGNS OF LOCAL FAILURE WHILE THE SECTION AS A WHOLE SHOWS VERY LITTLE DISPLACEMENT.

The behavior of section 4, which had a plasticity index of 17, was erratic. As previously noted, two soft spots developed in this section early in the compaction operation. Although these spots became firm before the surface treatment was constructed, they persisted as areas of local weakness throughout the early phases of testing with concentrated traffic. Immediately after the introduction of water into the subbase the passage of the wheels caused these spots to move visibly and to become depressed to such an extent that it appeared the section would fail.

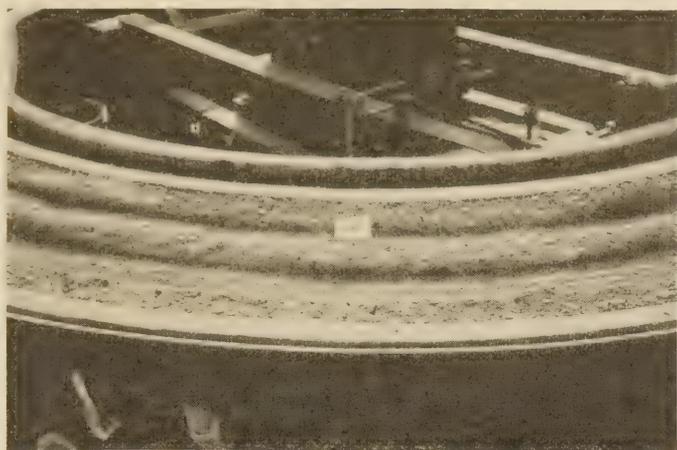
Section 4 failed as soon as traffic was resumed after increasing the water elevation. A mud-boil appeared at one of the soft spots at this time and the surface of the entire section moved under traffic. At 310,000 wheel-trips, the average vertical displacement of section 4 was almost 0.3 inch and the entire section was rated failed although traffic was continued to 434,000 wheel-trips in order to evaluate other sections. The appearance of section 4 at the end of traffic testing is shown in figure 5.

FIGURE 5.—SECTION 4 AT THE END OF THE TEST.
